West Onslow Beach Overwash 34° 30.70'N 77° 22.16'W

Undeveloped beach of Smith Island 33° 53.43'N 77° 57.08'W

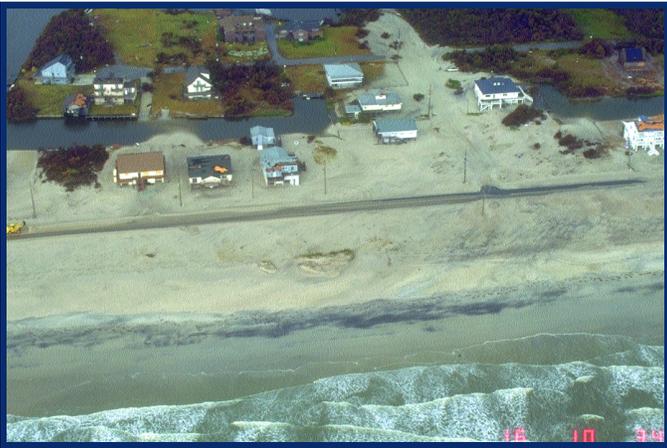
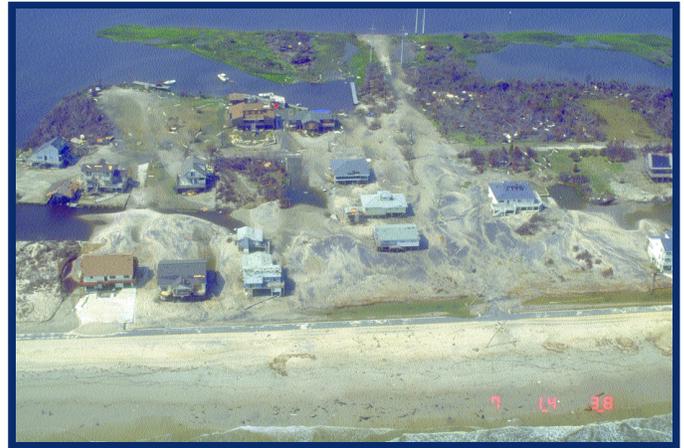
Areas overwashed by Bertha were more susceptible to erosion and overwash by Fran. At West Onslow Beach, overwash fans are observed after both storms but are more extensive after Fran. Overwash that initially carried sand into the finger channels behind the first row of houses during Bertha completely filled the channels during Fran. Initially susceptible to erosion during a category 2 hurricane, the area affected by the category 3 storm was greatly expanded. Standing water appears in many areas after Fran.

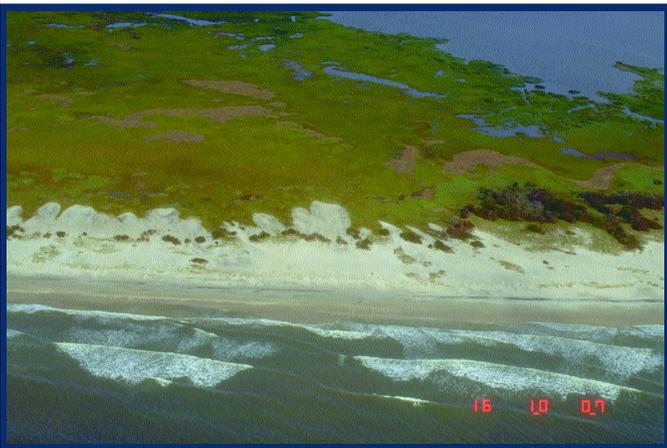
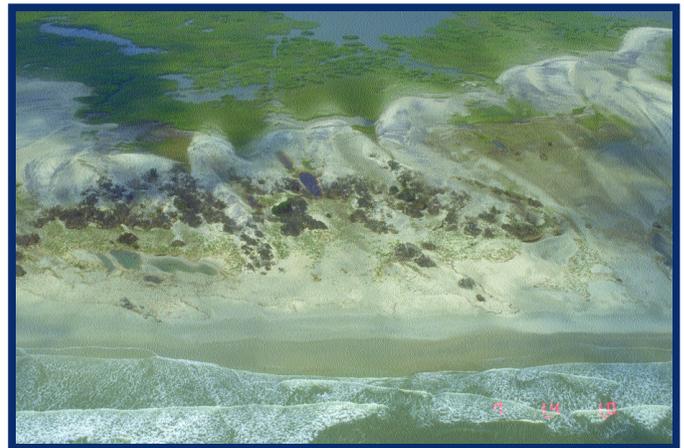
Photographs of an undeveloped coastline illustrate the contrast between Bertha, a category 2 hurricane and Fran, a category 3 hurricane. Some erosion as shown by the dune scarp and minor overwash occurred during Bertha; Fran caused major overwash fan deposits that extended into the back marsh. Finger-like projections visible as small overwash fans after Bertha were greatly extended after Fran. The large difference between these deposits show the value of surveying the undeveloped coastline for understanding geologic processes.
