BEFORE**AFTER****Topsail Beach Overwash 34° 24.05'N 77° 34.80'W**

BEFORE**AFTER****Topsail Beach Dune Erosion 34° 22.79'N 77° 36.47'W**

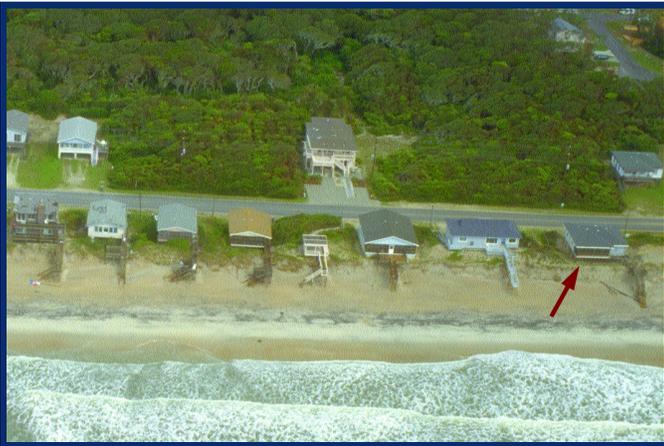
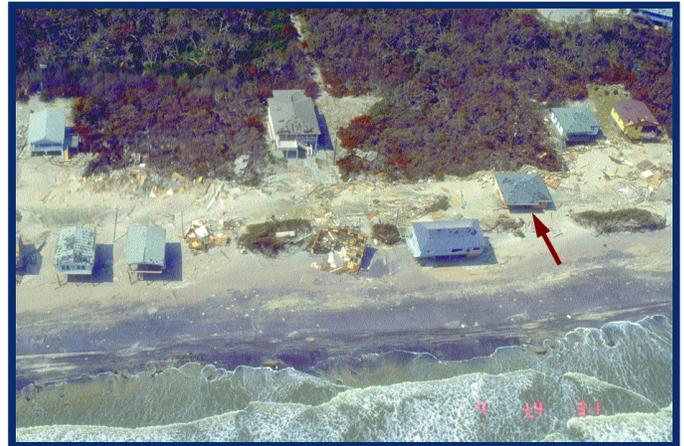
**Bertha 7/16/96 10:27 EDT****Fran 9/07/96 14:31 EDT**

The duneline, which was eroded but remained intact during Bertha, was destroyed and overwashed during Fran. Erosion has undercut many houses causing severe damage or total destruction. The force of the waves overwashing the dunes moved one house off its foundation and into the sand covered road behind its former location (red arrows). The storm surge deposited sand within vegetated areas, but the geometry of the overwash is obscured by the canopy. The dark sand on the beach is formed by heavy minerals that are typically concentrated on the beach during erosion. A thin band appears after Bertha with a wide deposit as a result of Fran.

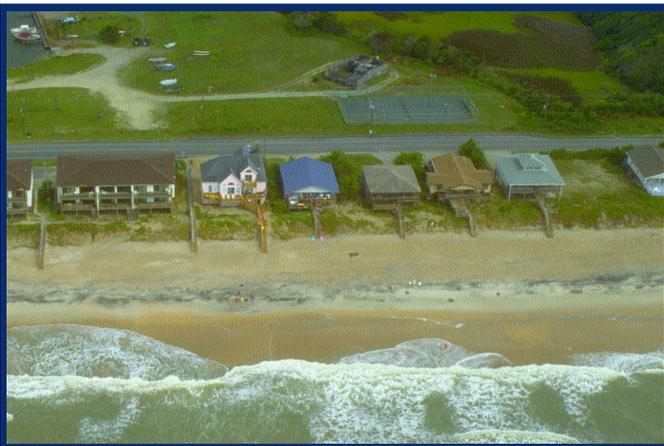
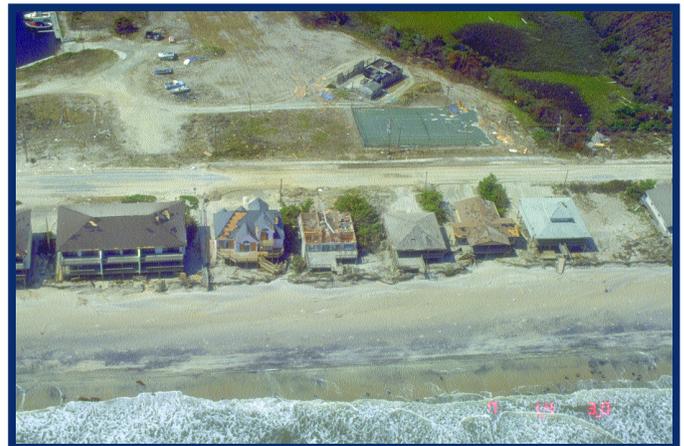
**Bertha 7/16/96 10:26 EDT****Fran 9/07/96 14:30 EDT**

The dune line in front of the apartments seems intact with minor erosion at the base after the passage of Bertha. After Fran, the dune was eroded to the first line of houses, leaving a new scalloped scarp line. In a few places the dune was breached.
