**Topsail Beach Pier 34° 21.87'N 77° 37.59'W**

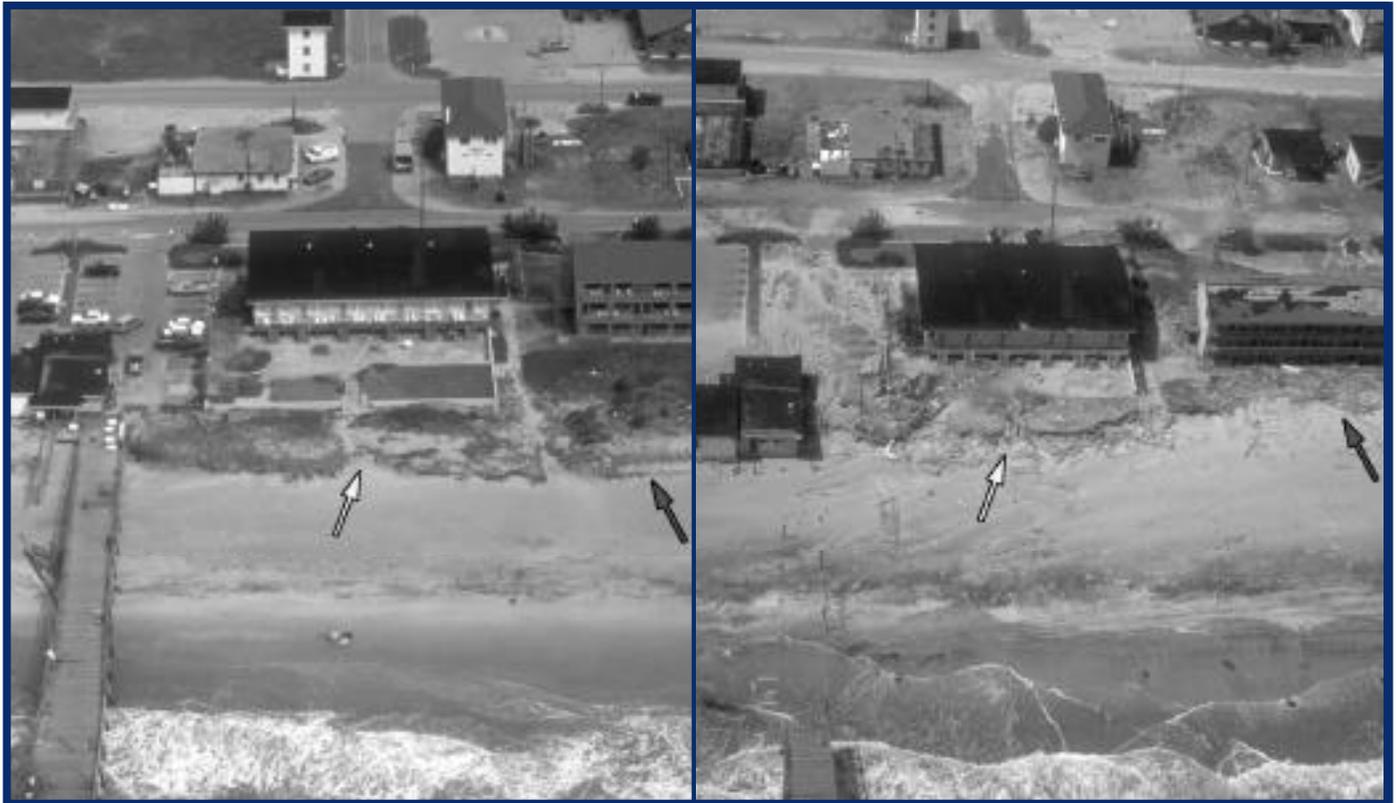
**Bertha 7/16/96 10:25 EDT**

**Fran 9/07/96 14:29 EDT**

Many piers damaged during Bertha were destroyed during Fran. The pier at Topsail Beach sustained only minor damage after Bertha and was open a few days after the storm. Storm waves from Fran removed the section of the pier closest to the beach. The dune line which held during Bertha (to the left of the pier) was completely removed and the retaining wall behind it destroyed, leaving debris scattered in front of the buildings (light arrows). Further to the right a low dune line is replaced by an erosional scarp (dark arrows). Sand extends to third row of houses and appears to come from the left.
