Coastal Change During the 2008 Hurricane Season: An Overview

USGS *National Assessment of Coastal-Change Hazards*

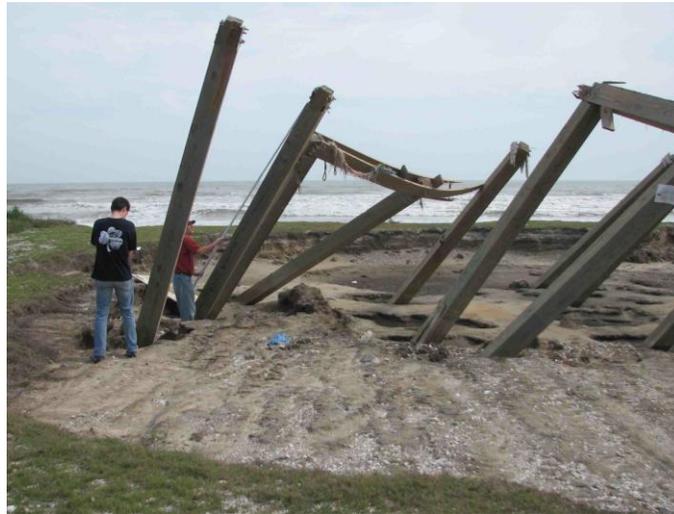
Figure 1. The remains of a Gulf-front home destroyed by Hurricane Ike on the Bolivar Peninsula, Texas. Waves and currents eroded the large depression. The piles tilt in the direction that the waves were propagating (Photo: 3/8/2009).

- **Structural failures can be caused**, or exacerbated, by waves undermining buildings, such as in Figure 1 and also the collapse of 5-story condominium towers in Alabama during Hurricane Ivan in 2004. (See <http://coastal.er.usgs.gov/hurricanes/ivan/photos/index.html>)

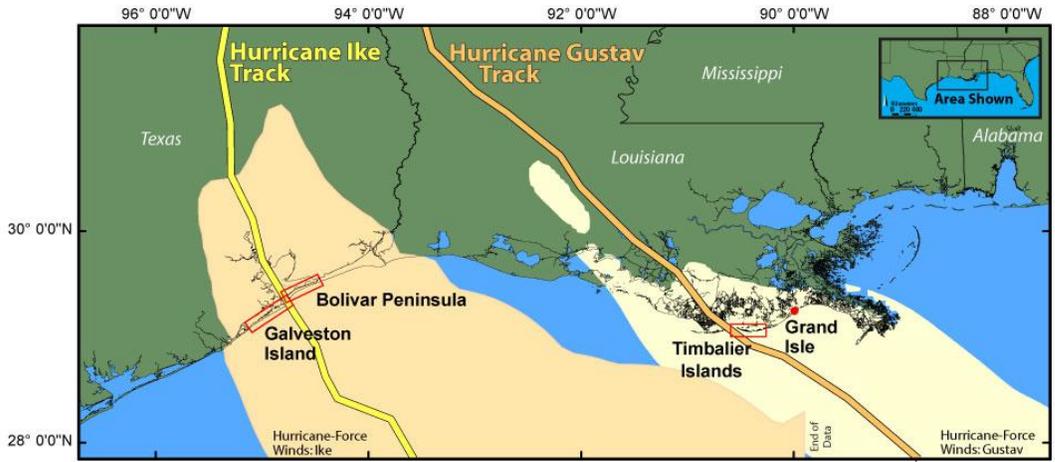
Figure 2: Hurricane-force wind fields and tracks of Hurricanes Gustav and Ike. Red boxes show the extent and location of areas referred to in the text.

Hurricane-force winds of Gustav impacted approximately 280 km of the Gulf Coast. This was an unusually widespread impact, partly because the storm itself was broad and partly because the track was about a 45° angle to the shoreline (Fig. 2). The strongest onshore winds were located east of landfall in the right-front quadrant of the storm. Here, onshore hurricane-force winds extended from landfall to the east for 160 km. In contrast, the track of Hurricane Ike was near 90° to the shoreline, and hurricane-force winds extended along the shore about 200 km. To the east of landfall, onshore hurricane-force winds extended for about 125 km.

The central Louisiana coast where Hurricane Gustav made landfall has historically undergone rapid erosion. Between 1887 and 1988, the Gulf shore of the Timbalier Islands (just east of landfall, Fig. 2) eroded landward 1515 m, an average rate of 15 m/yr (Williams et al., 1992). The time between pre- and post-Gustav lidar surveys was only 6 months; if the long-term erosion proceeded steadily, then this period included about 8 m of long-term erosion. Hence, the remaining shoreline erosion that occurred in a few hours during Hurricane Gustav (33 m) represents over two years of the average long-term change of the island.

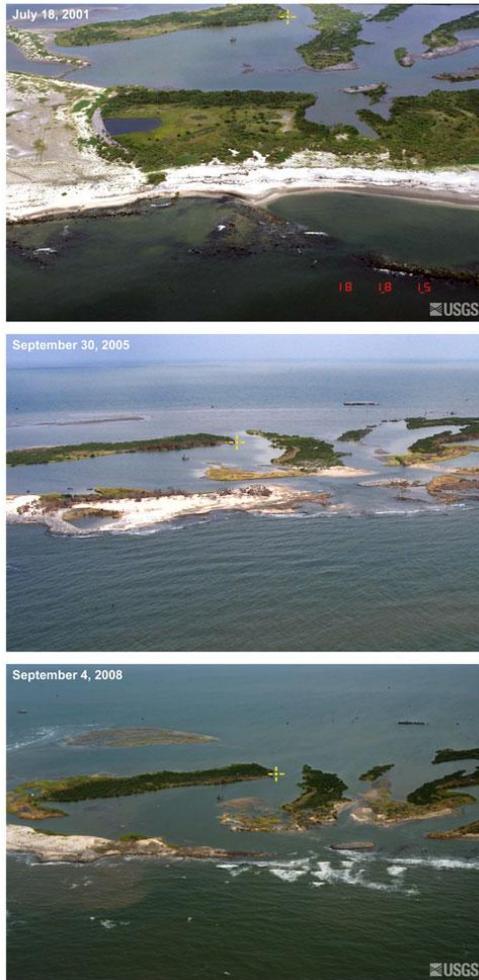
Figure 4. Deterioration of East Timbalier Island between 2001 and three days after Hurricane Gustav.
